NEW FAA-PMA FUEL GAUGES

**FAA-PMA
Stearman Fuel
Gauge**

Stearman Fuel Gauge

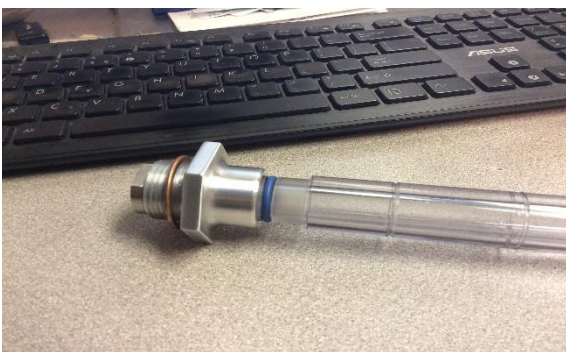
This shows the O-Ring seal installed at the top of the sight tube to create a positive seal.

The leaking problem with these fuel gauges was the next problem to solve. We designed the top portion of the tube to accept an O-Ring seal. We experimented with two O-Rings instead of one, but found that two can cause problems getting O-Rings to seal properly. The one ring seal has proven superior. We are using the best material available for the sealing ring. At the same time the upper portion of the tube was redesigned so it was adjustable. This change makes it so the sight tube can be turned after installation so the numbers face the pilot. No loosening is required, just simply turn it with your fingers and leave it.
